# MALAD CITY AIRPORT

This report describes how your pavement maintenance management program was developed. This program was developed as part of the Network Pavement Management Program project sponsored by the Idaho Transportation Department, Division of Aeronautics. The information and data contained in this report ensures you are in compliance with the requirements of Federal Aviation Administration (FAA) Grant Assurance Number 11 which states that any airport requesting federal funds for pavement improvement projects must have implemented a pavement maintenance management program (PMMP).

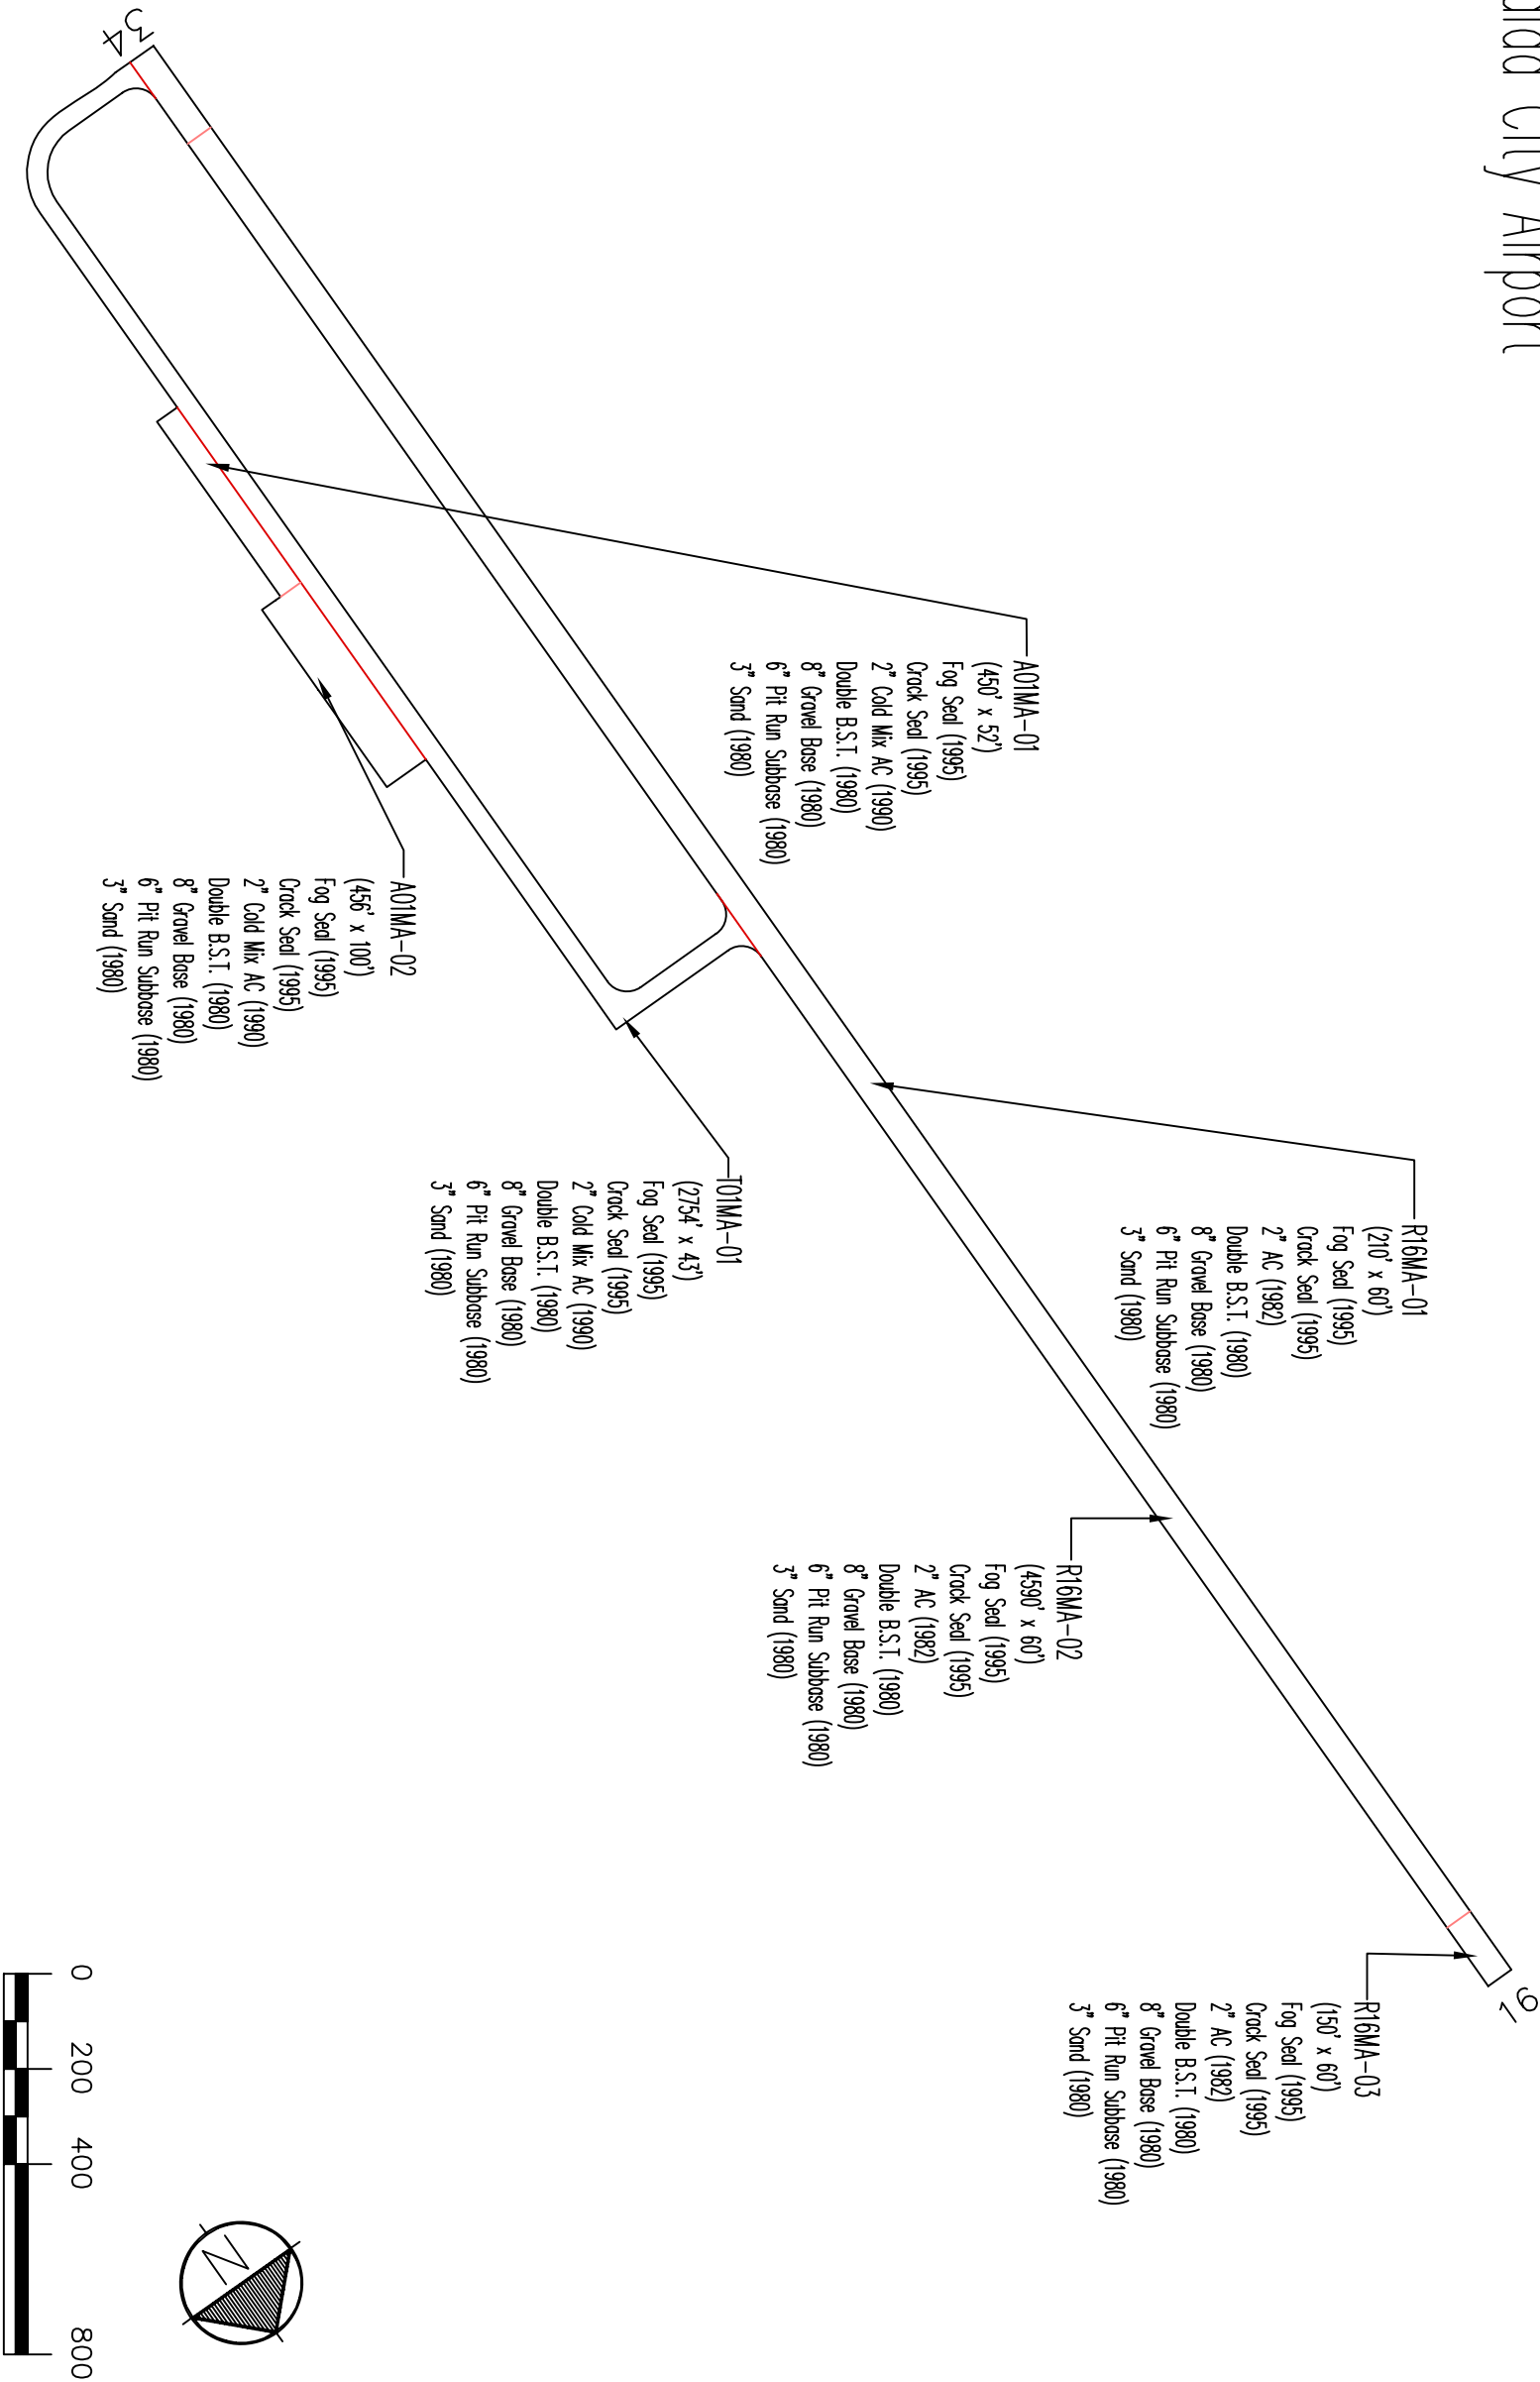
Figure MA-1. Airport Layout, Pavement and Dimensions Cross-Sections.  
Malad City Airport

To determine how your pavements were constructed and their age, a records review was conducted. Figure MA-1 shows the records review results. This figure shows pavement boundaries, dimensions, pavement layer types, thicknesses and dates of construction. Table MA-1, provided in Appendix 1, contains the up-to-date cross-section information for each pavement section. The most recent construction date for each pavement can also be found in the Section Condition Report in Appendix 2. Figure MA-1, Table MA-1, and the information contained in Appendices 1 and 2 ensure that your airport complies with the “pavement inventory” requirement of FAA’s PMMP guidelines.

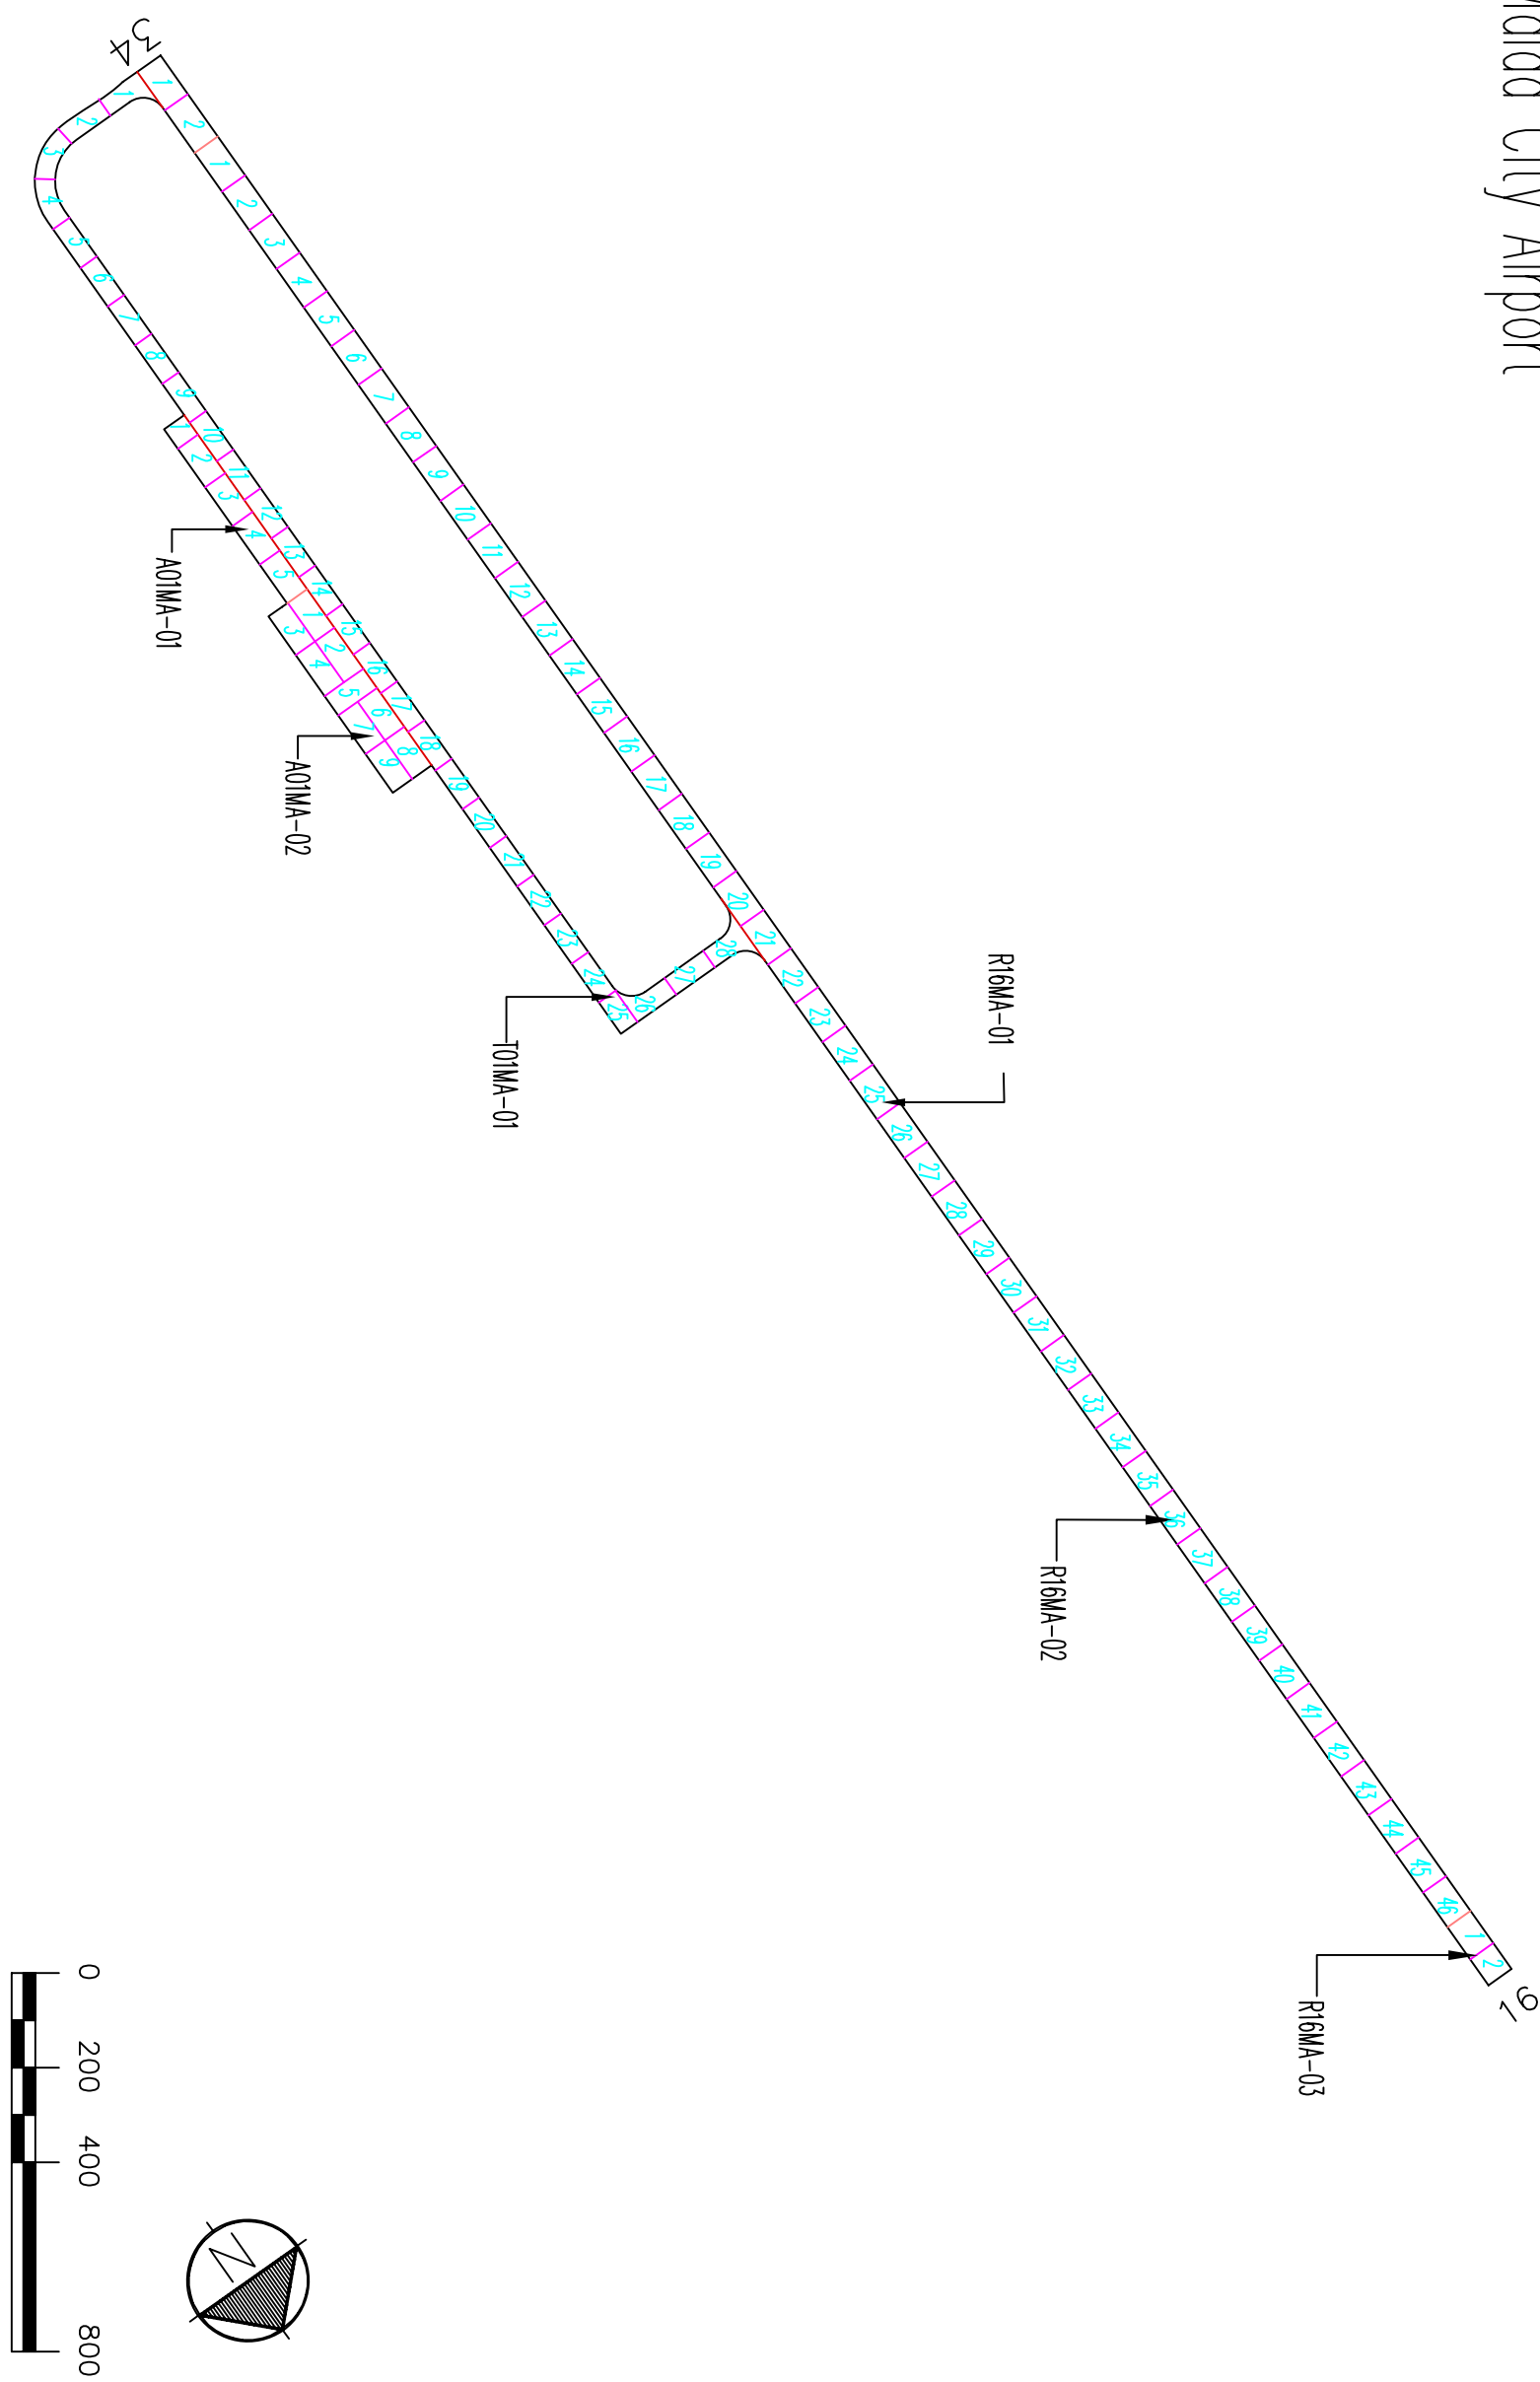
Figure MA-2. Pavement Branch, Section and Sample Unit Layout.  
Malad City Airport

The pavements at your airport were divided into branches, sections and sample units in accordance with the methodology outlined in the current editions of FAA Advisory Circular AC:150/5380-6, *Guidelines and Procedures for Maintenance of Airport Pavements* and ASTM D5430, *Standard Test Method for Airport Condition Index Surveys*. The branches, sections and sample units established at your airport are shown in Figure MA-2. A Branch Condition Report showing all branches, their associated areas, and area-weighted average condition is provided in Appendix 2. Additionally, the Appendix 2 Section Condition Report provides information that the Micro PAVER pavement management software uses to define each branch and section.

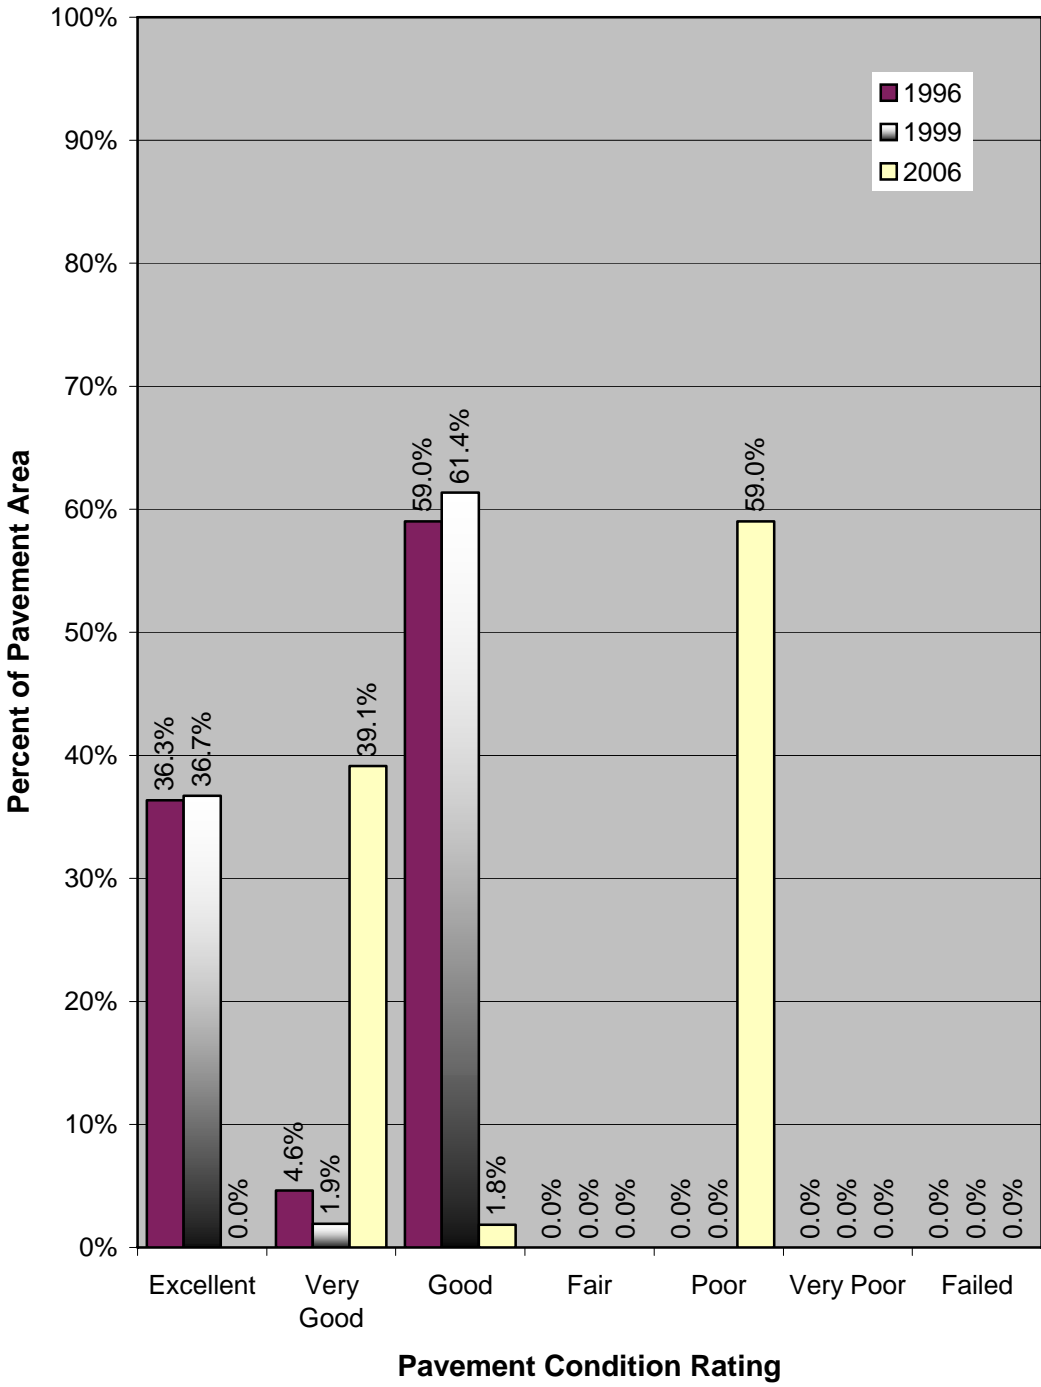
**Figure MA-4. Distribution of Pavement Condition  
Malad City Airport**

Section PCIs at the airport range from a low of 28 (a PCR of “Poor”) to a high of 81 (a PCR of “Very Good”). The area-weighted average PCI for all airport pavements is 51, corresponding to an overall PCR of “Fair”. Figure MA-4 shows how much pavement area is associated with each Pavement Condition Rating category and also shows pavement condition distribution from the inspections conducted in 1996 and 1999. A graphical representation of the projected PCRs presented in Table MA-2 is shown in Figure MA-5.
